Rimkus Consulting Group, Inc.
Eight Greenway Plaza, Suite 500
Houston, TX 77046
(800) 580-3228 Telephone
(713) 623-4357 Facsimile

Re: RCG File No: 11009971
LLV Number: 0209452
VMF Location: 1530 Greensmark Drive in Houston, Texas
Subject: Final Report

Rimkus Consulting Group, Inc. was retained to examine LLV 0209452, VIN 1GBCS10E4M2908832. The fire occurred on June 13, 2016 at around 12:30 P.M. the operator of the vehicle at the time of the fire, was unavailable for interview but reportedly stated the vehicle's engine died while delivering mail on his route and backfired during subsequent attempts to restart it. Soon thereafter, smoke was observed from beneath the hood as well as flames.

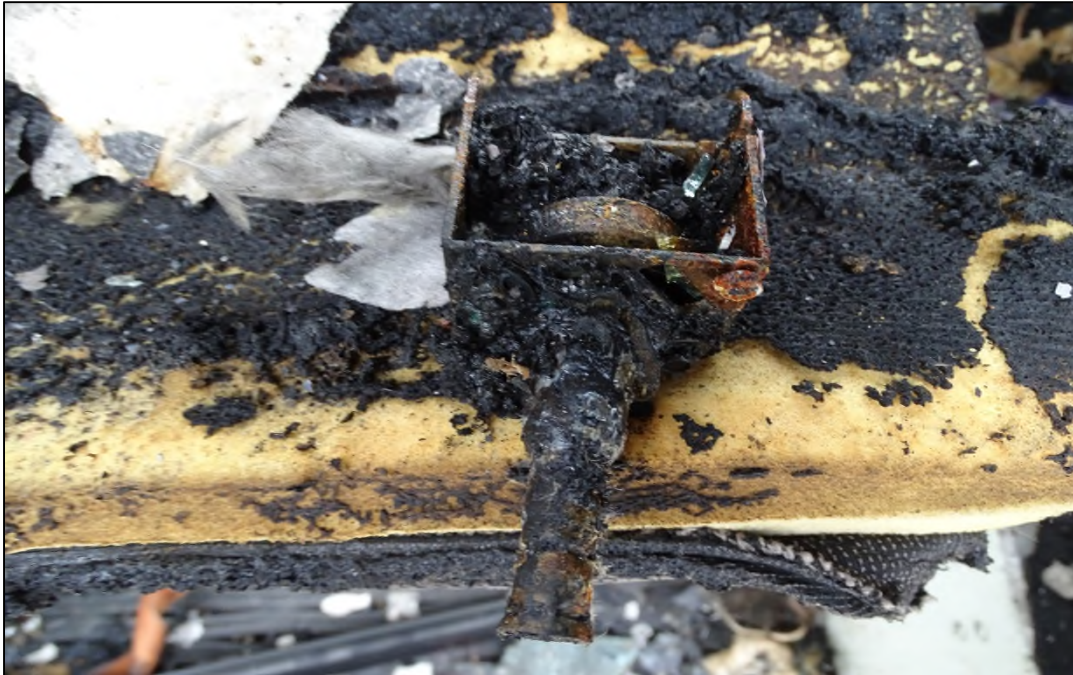
Photograph 5

The remains of the head light switch assembly.

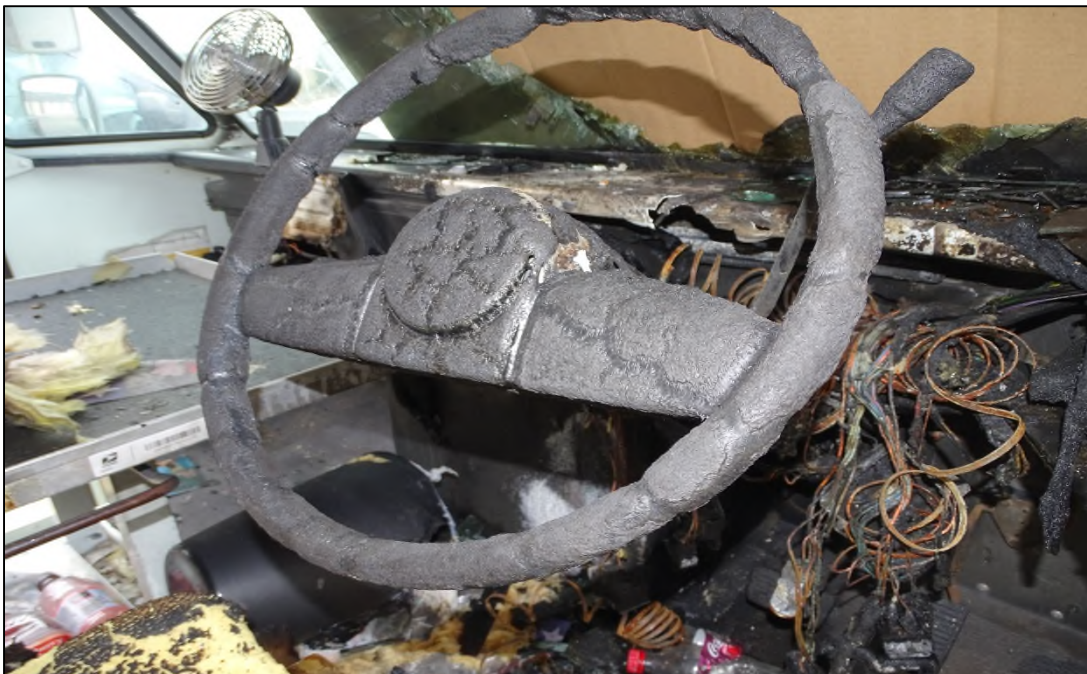
Photograph 6

The steering wheel and column; observe the severe fire damage to the dashboard area.

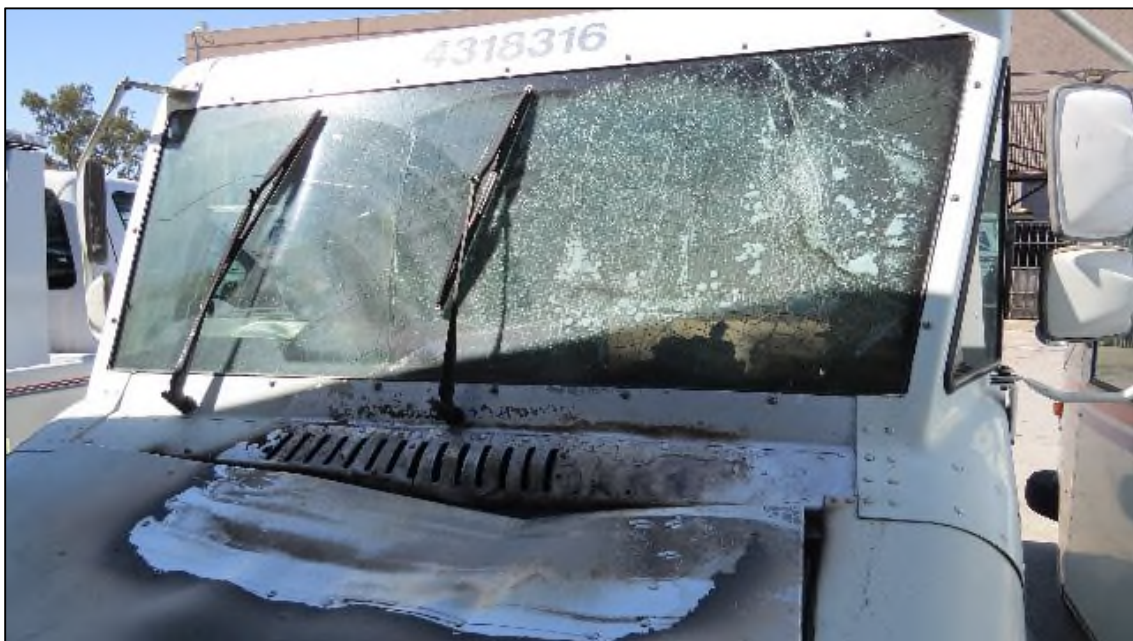
Photograph 2

Exterior fire damage.

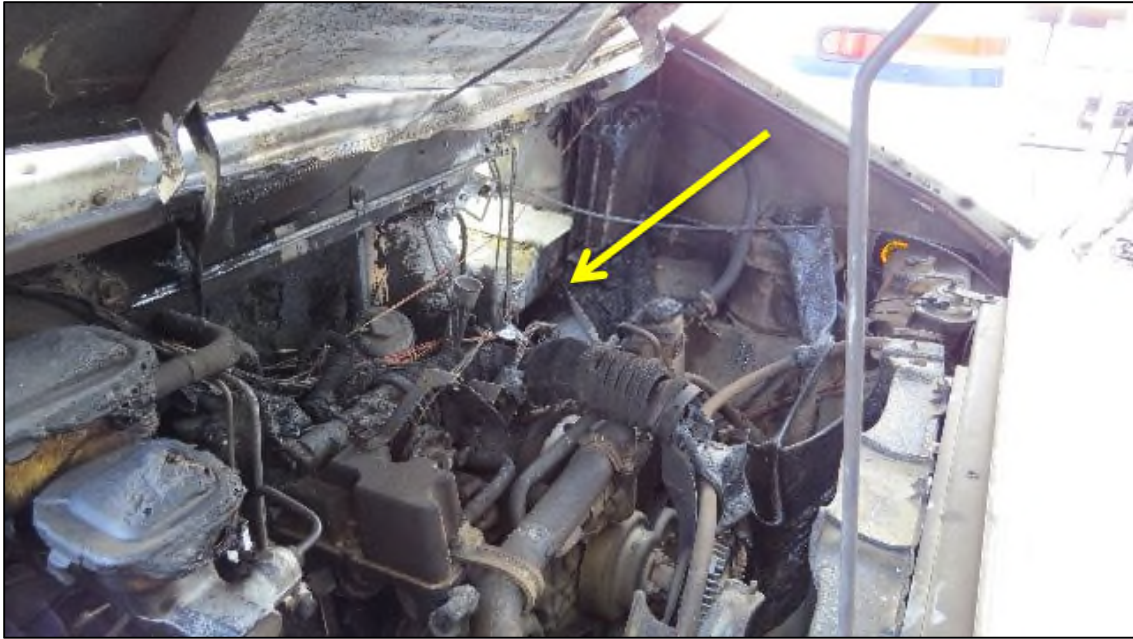
Photograph 3

Fire damage to engine. Hole melted through firewall.

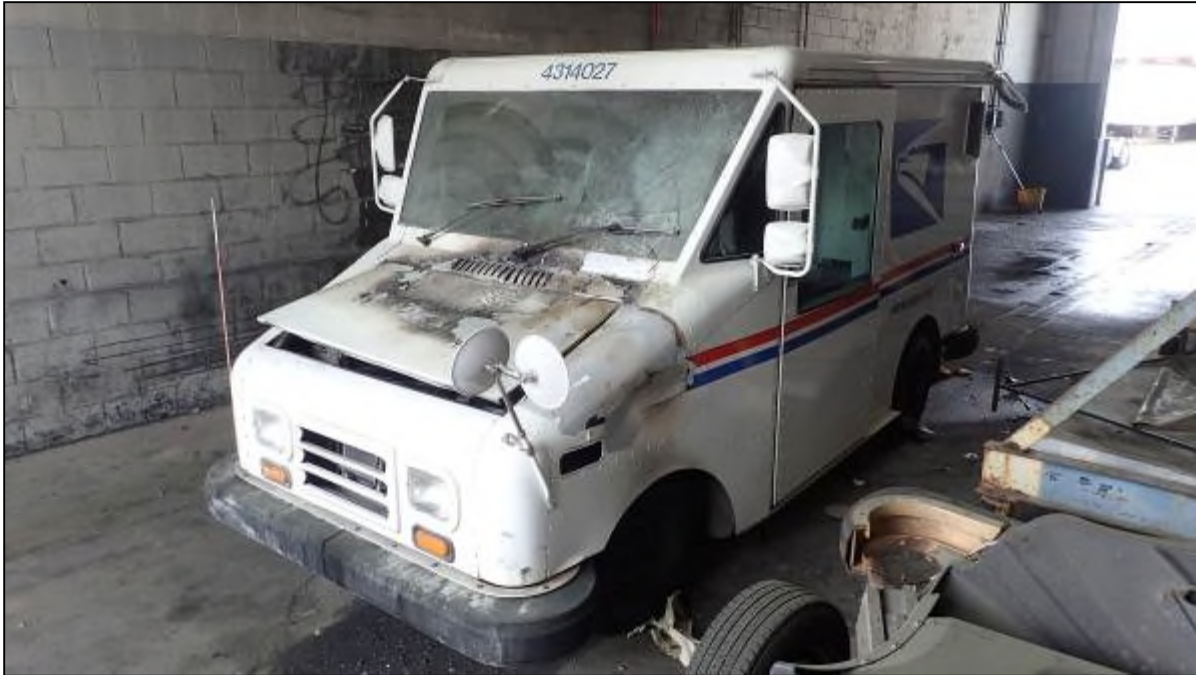
Photograph 1

View of the exterior fire patterns.

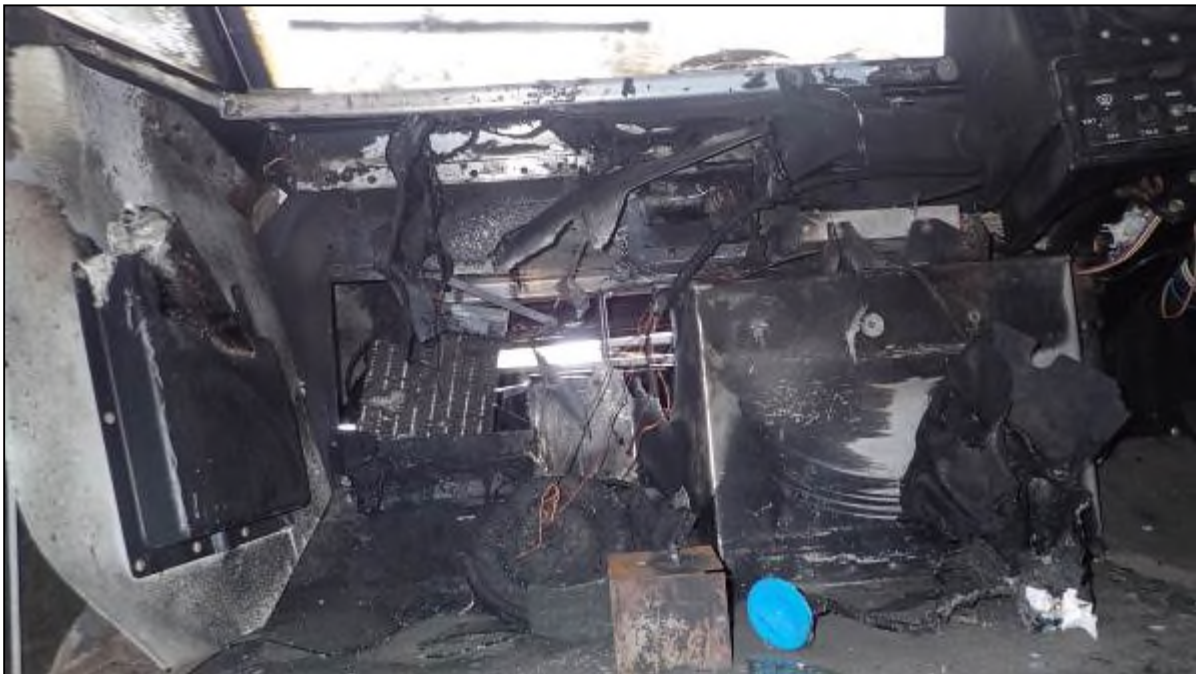
Photograph 2

View of the interior fire damage along the left side of the bulkhead.

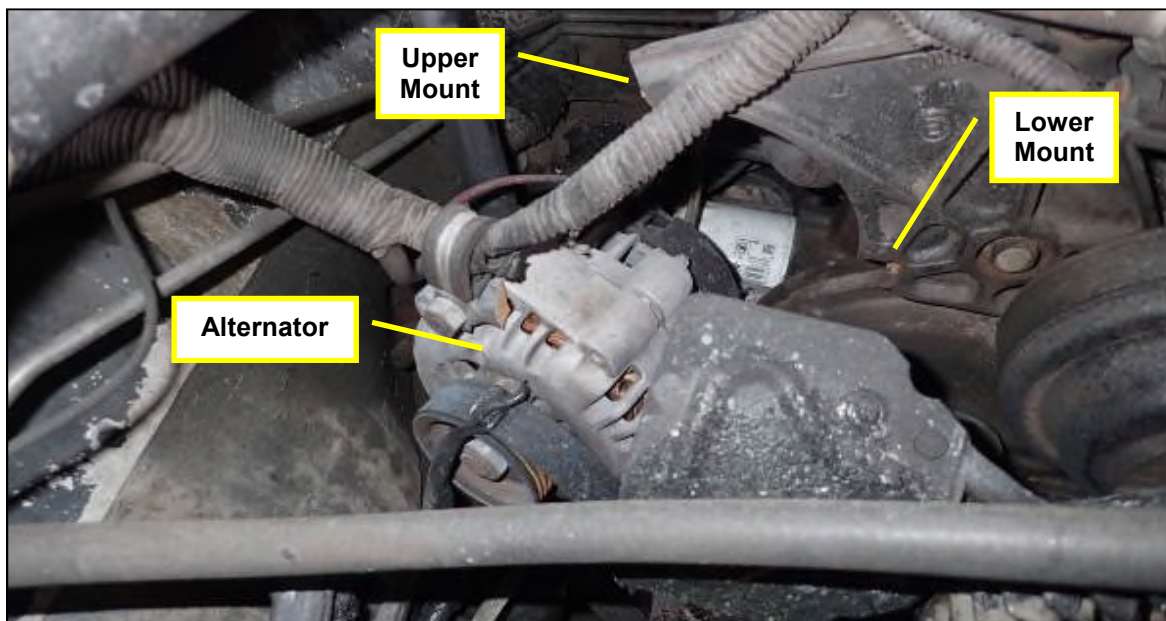
Photograph 4

View of the alternator and alternator mounts.

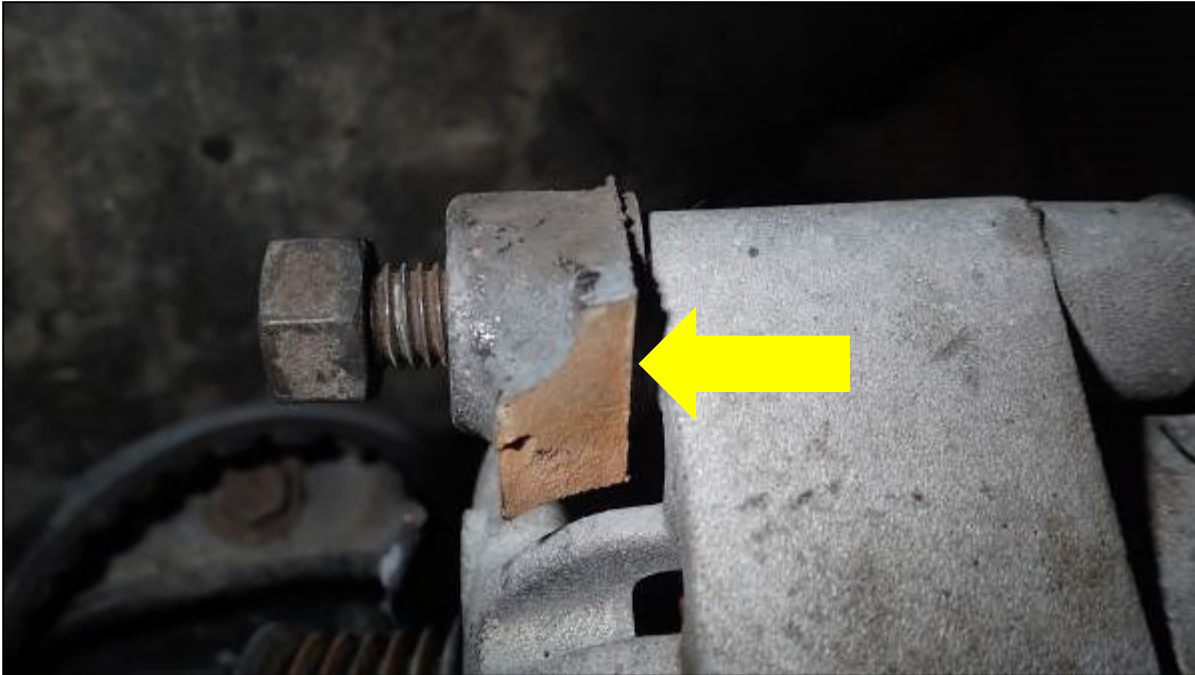
Photograph 5

View of the mechanical damage to the upper alternator mount on the alternator.

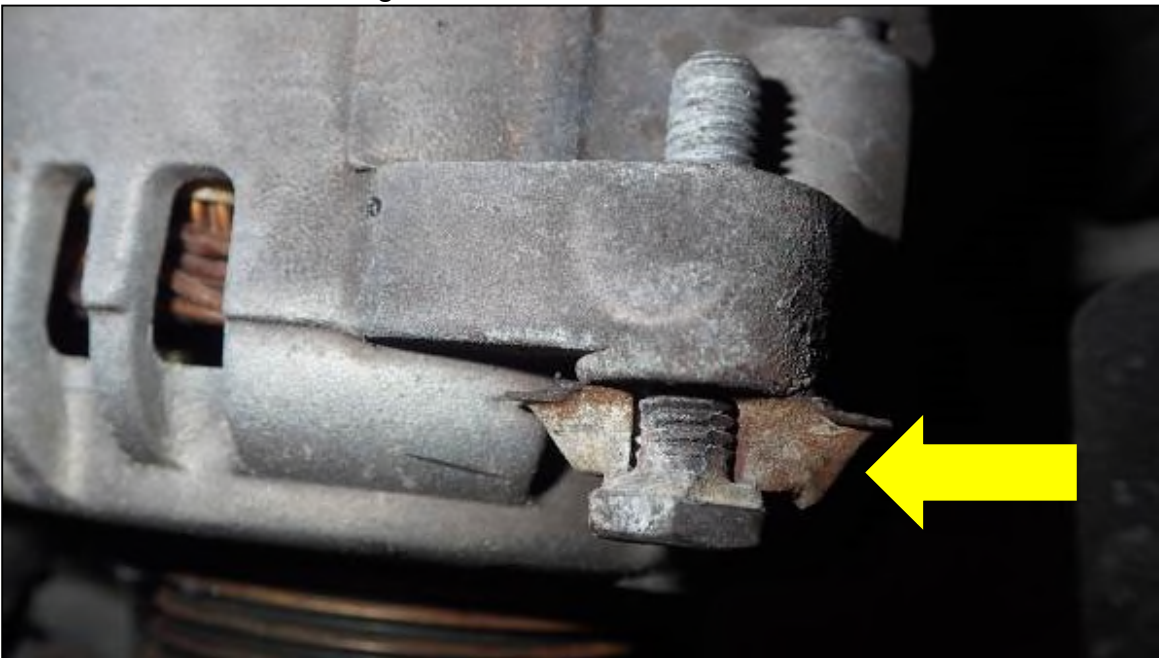
Photograph 6

View of the mechanical damage to the lower alternator mount on the alternator.

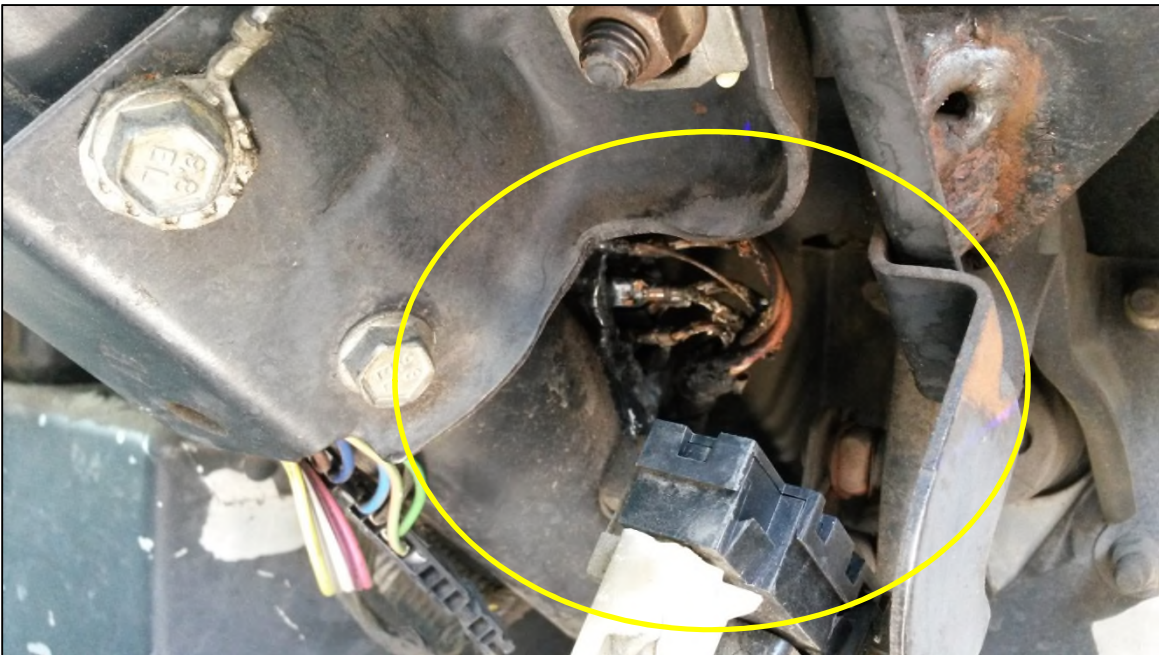
Photograph 6

The ignition switch and wiring harness, observe the damage to the wiring harness at the connection terminals.

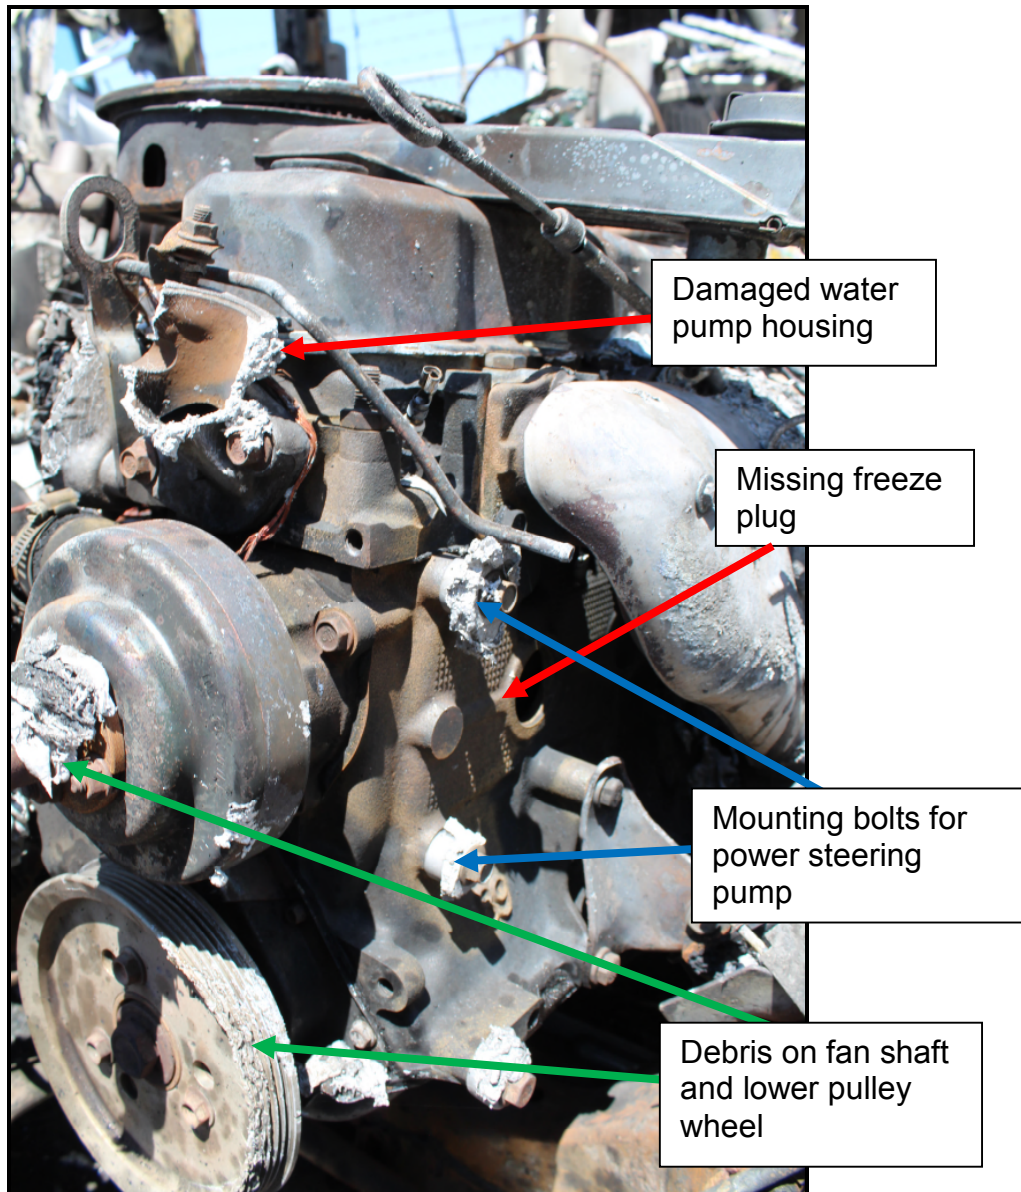
Photograph 17

L-side of engine showing noted issues, components.

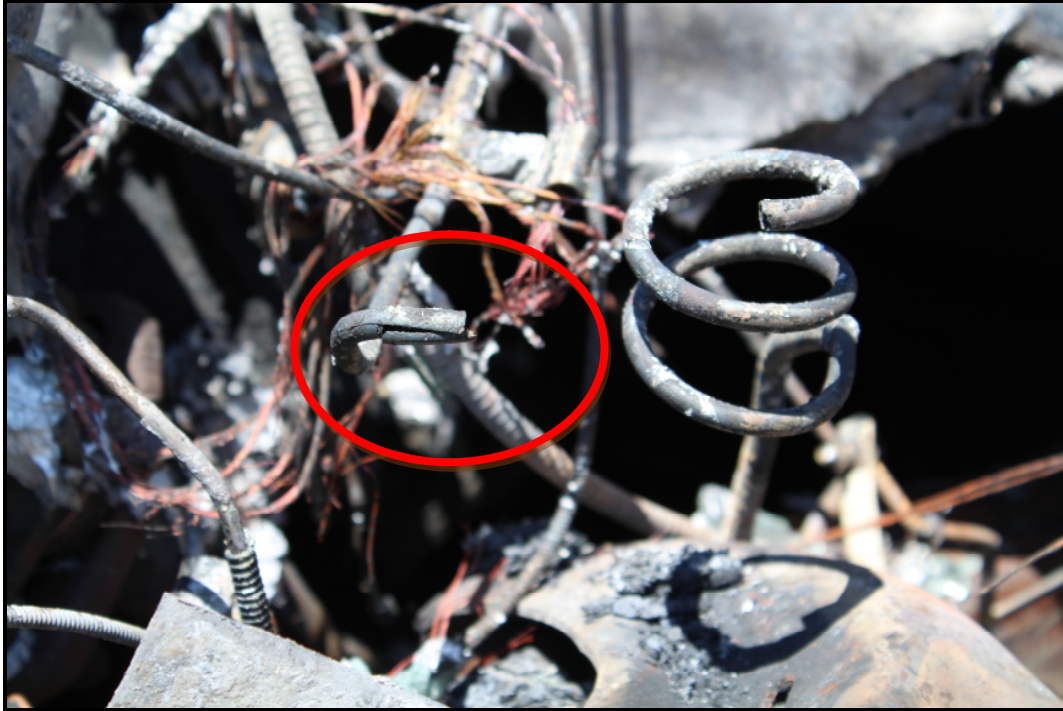
Photograph 18

Line with horizontal fracture near conductors and other detached line.
Engine block is to the left of this component.

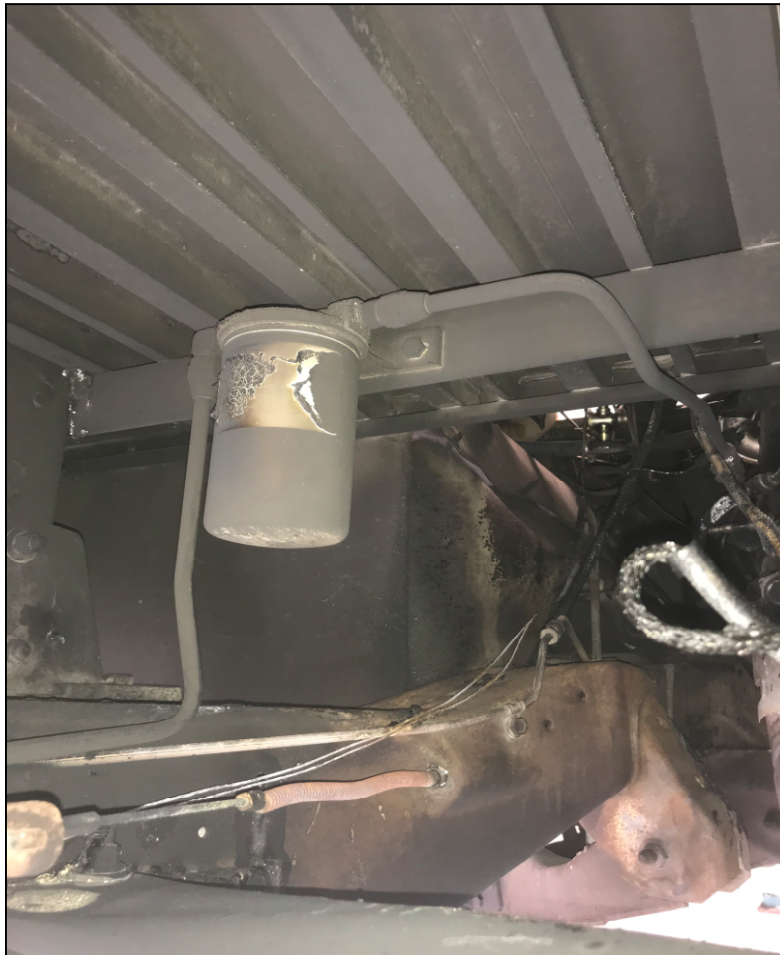
Photograph 3
Fuel filter (replaced 7/24/17).

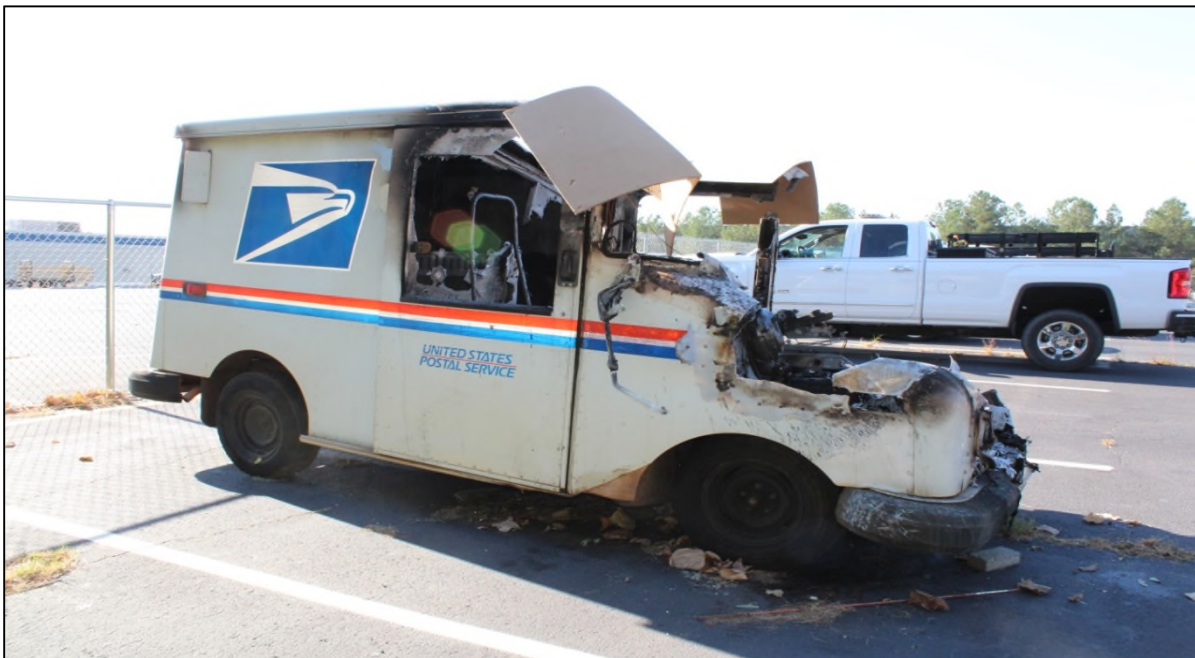
Photograph 2

Severe fire damage to the front engine compartment of the vehicle.

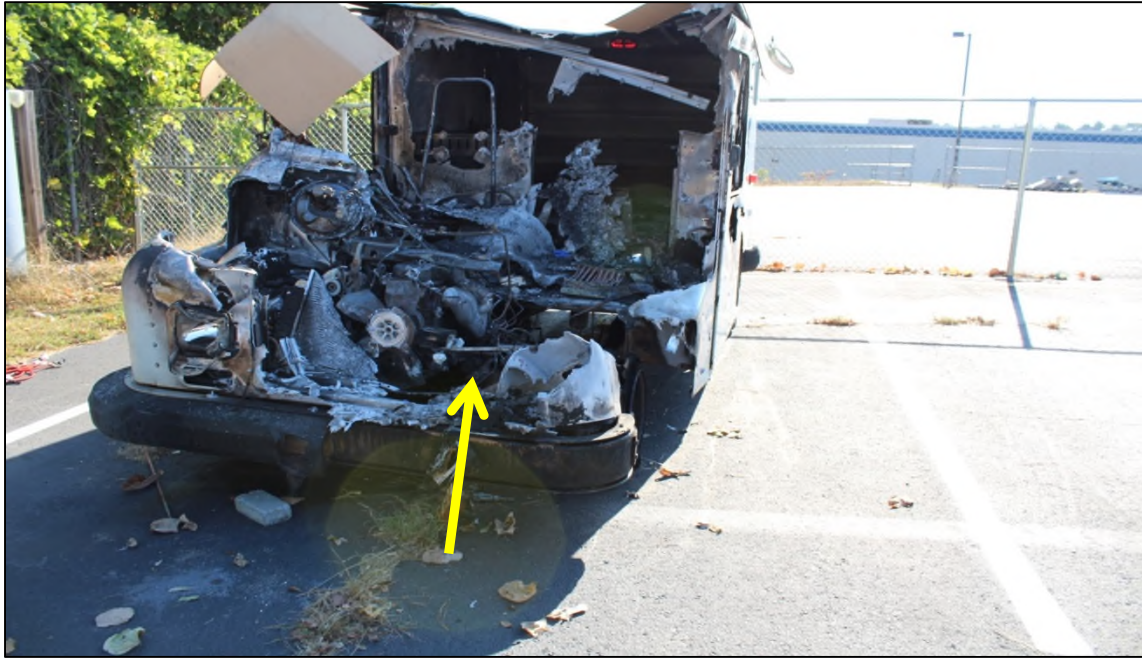
Photograph 3

Severe fire damage to the left side of the engine compartment.

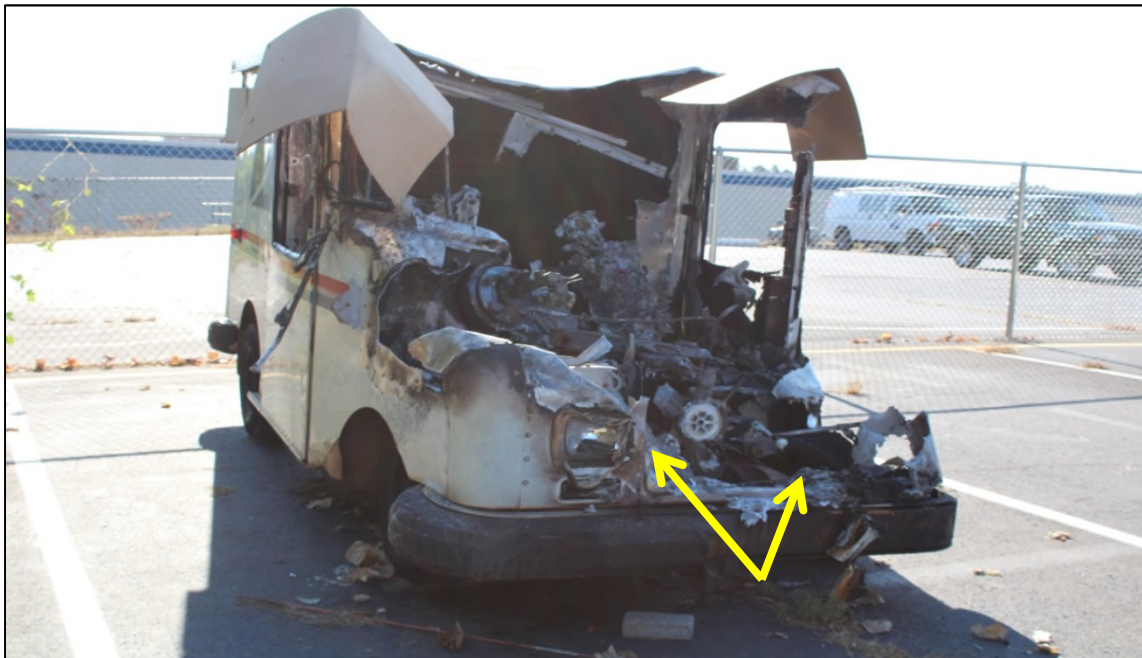
Photograph 4

The upward and outward progression of the burn patterns from the left side.

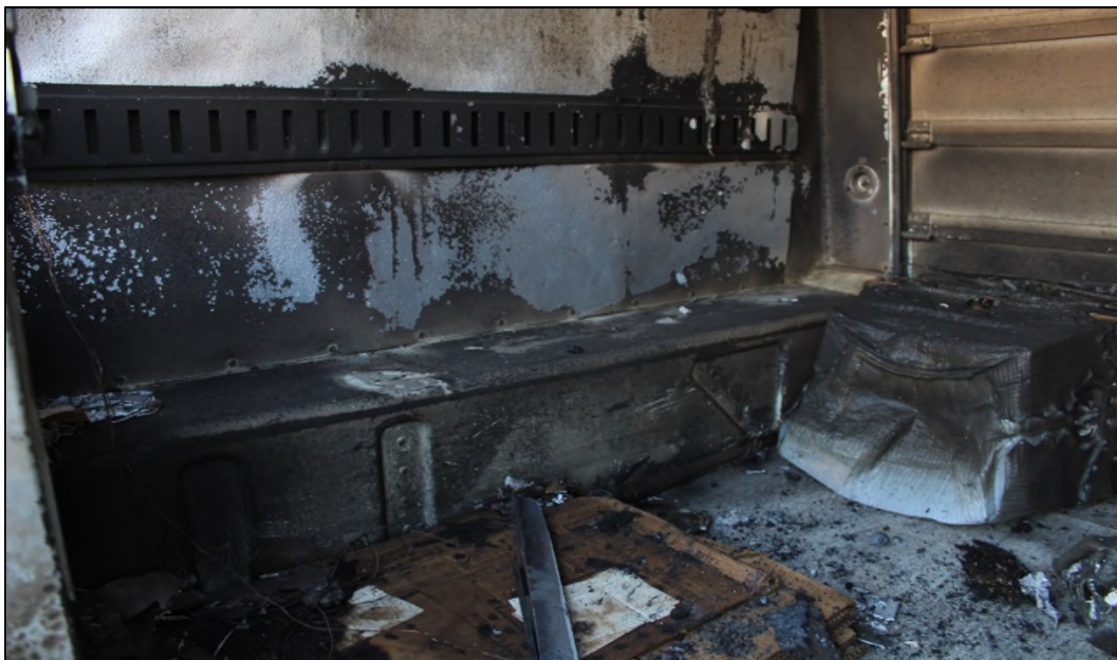
Photograph 8

The minor fire damage to the cargo area of the vehicle.

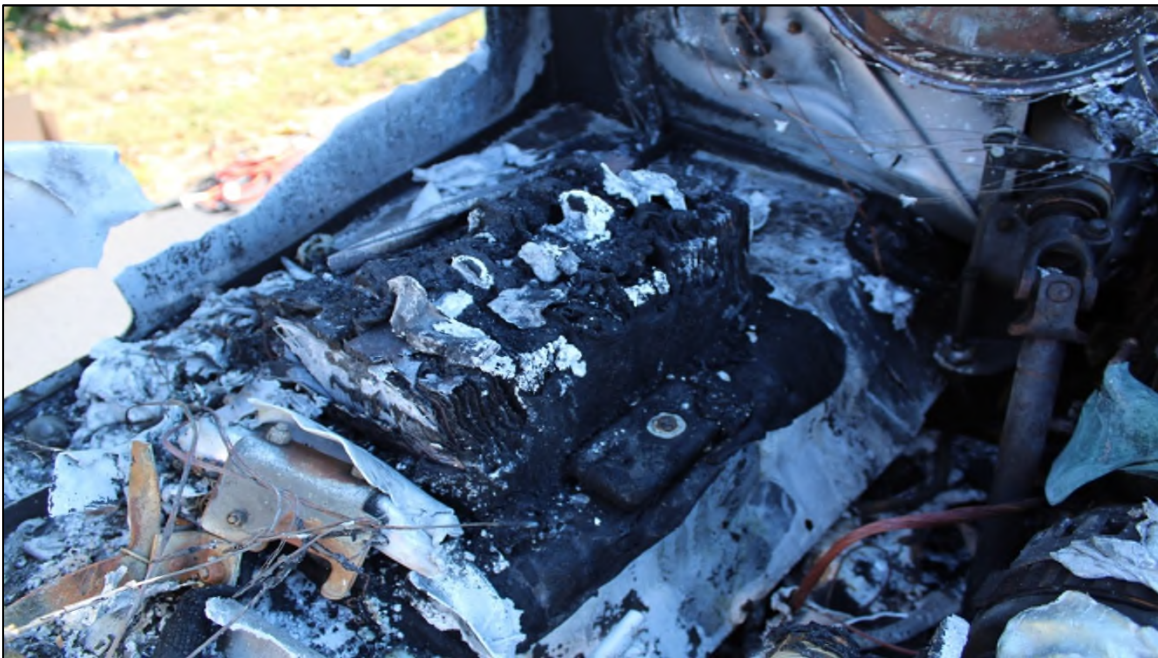
Photograph 10

The vehicle battery, no adverse electrical activity was observed.

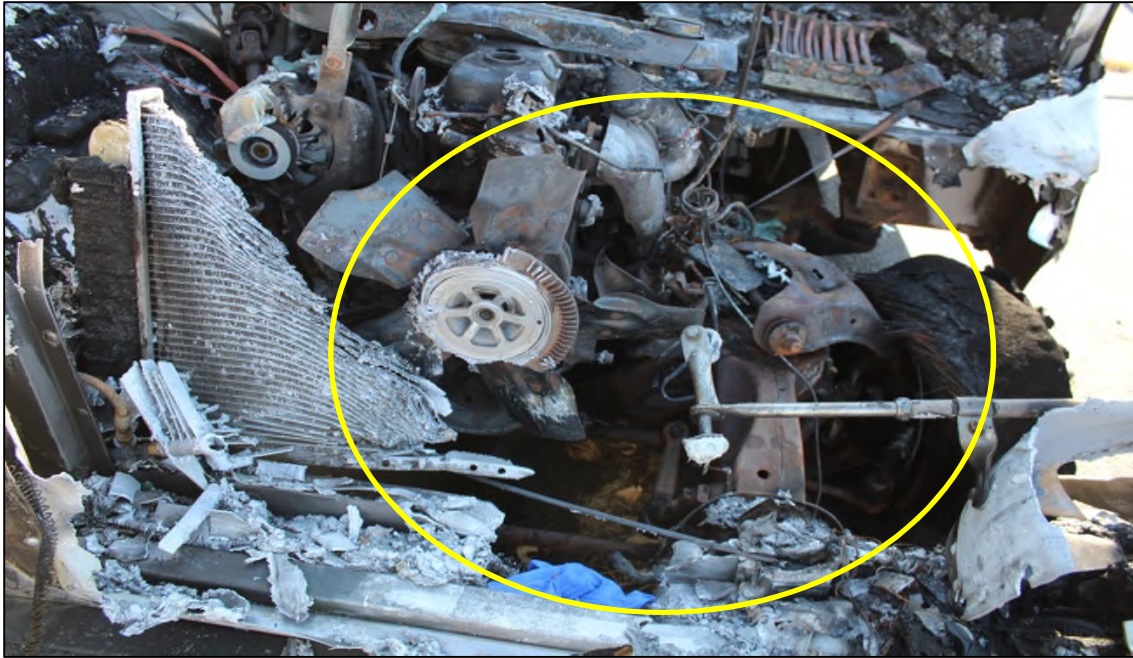
Photograph 11

The engine compartment, observe the more severe damage to the left side.

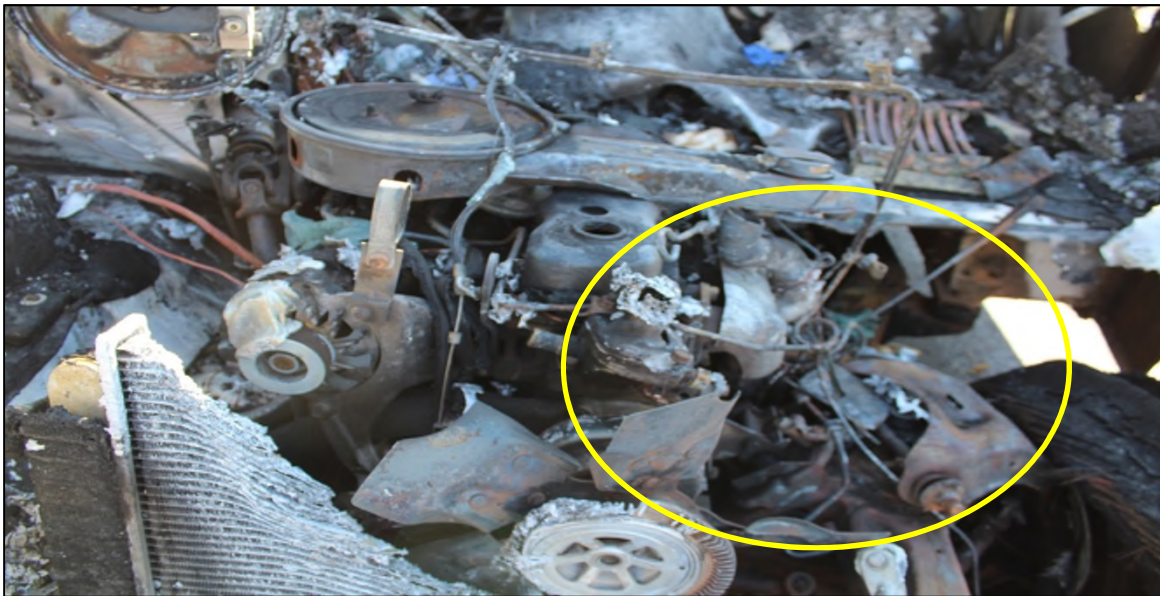
Photograph 12

Observe the upward and outward progression of the burn patterns from the left side of the engine in the area of the exhaust manifold.

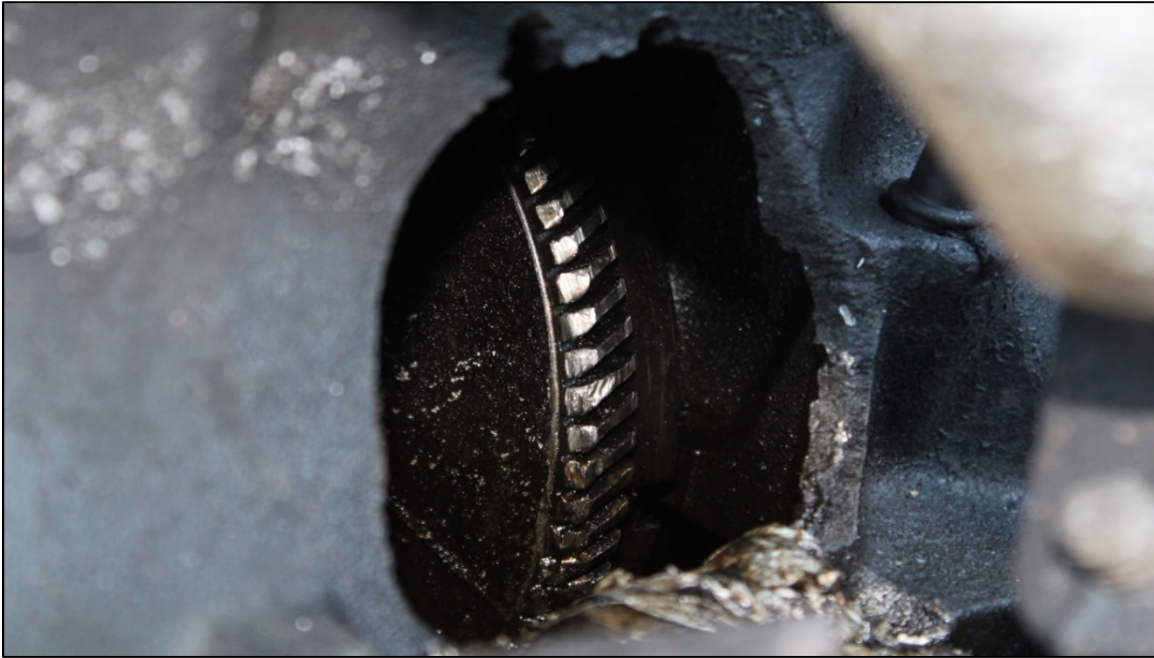
Photograph 15

A closer view of the hole in the engine block.

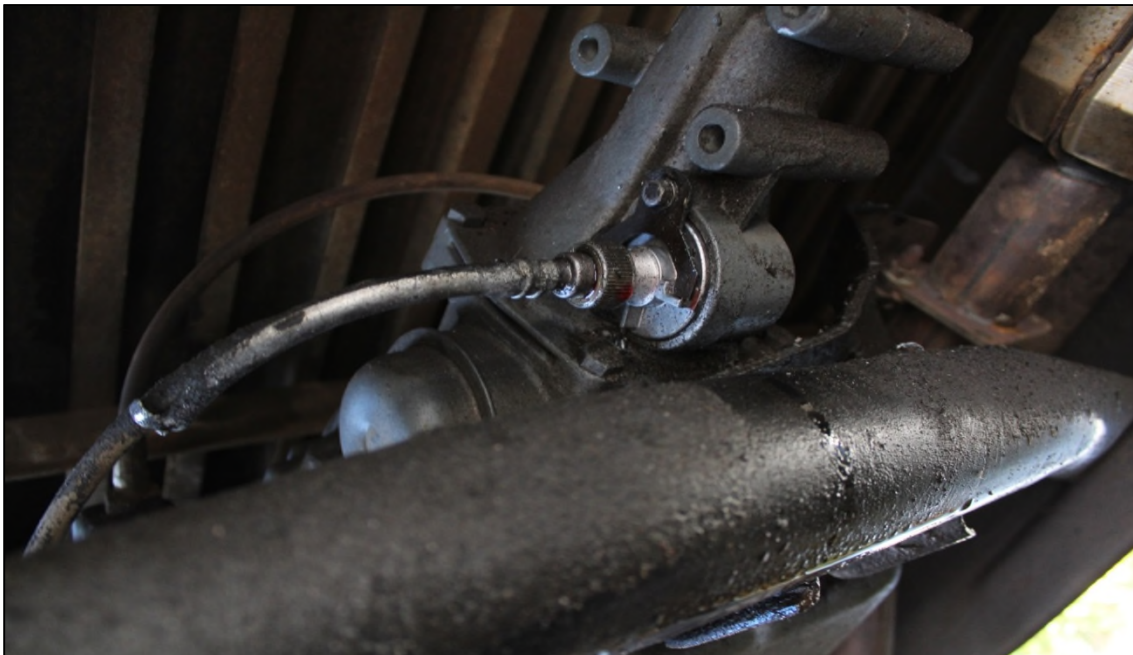
Photograph 16

The speedometer gear housing that was replaced the day of the fire, observe the fluid on the undercarriage.

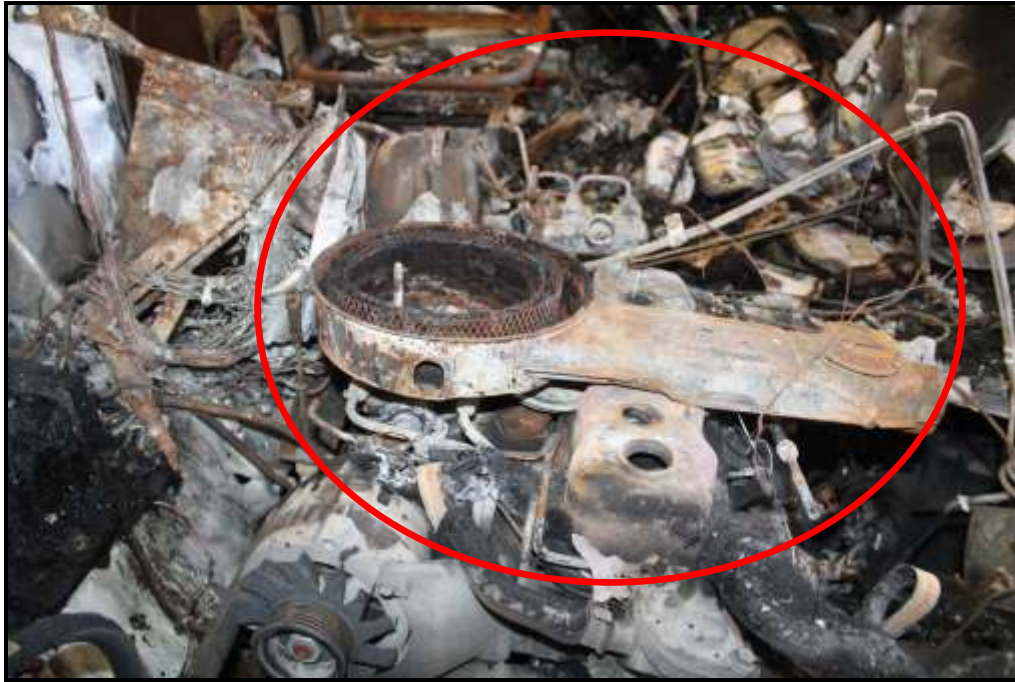
Photograph 5

The engine compartment, observed the most severe fire damage to the mail side.

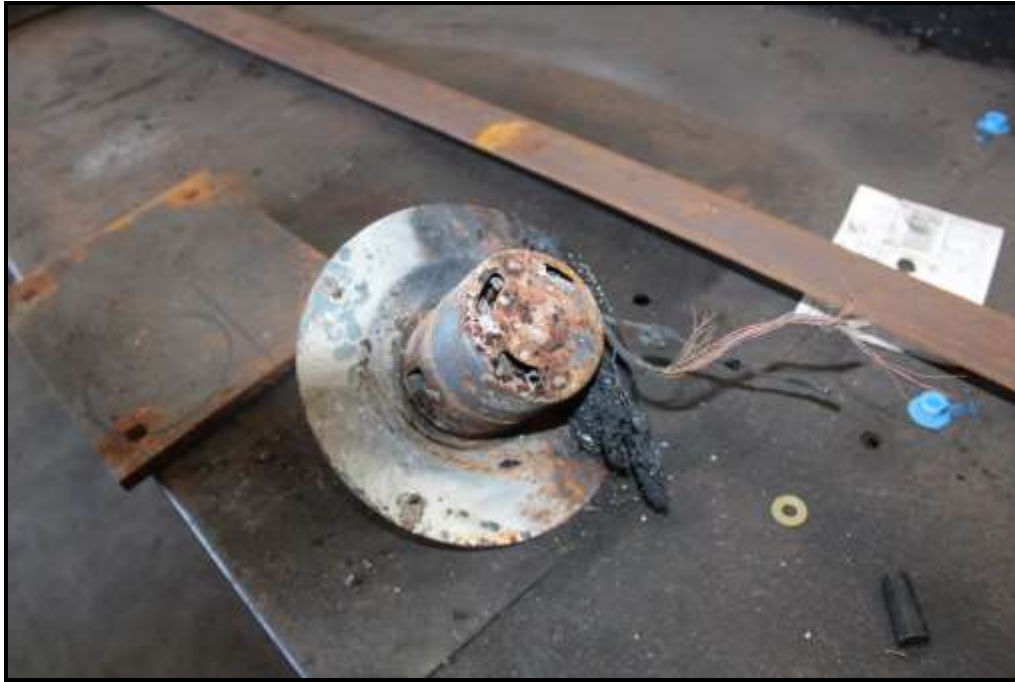
Photograph 9

The auxiliary fan, the motor would not turn.

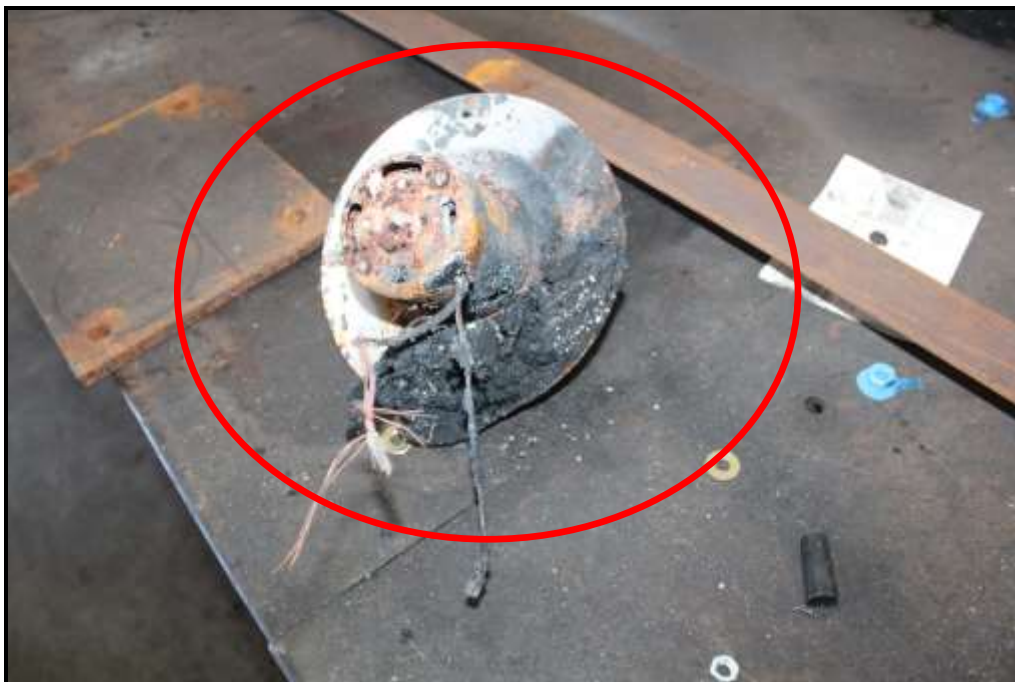
Photograph 10

Observed the severe fire damage progressing from the fan motor area.

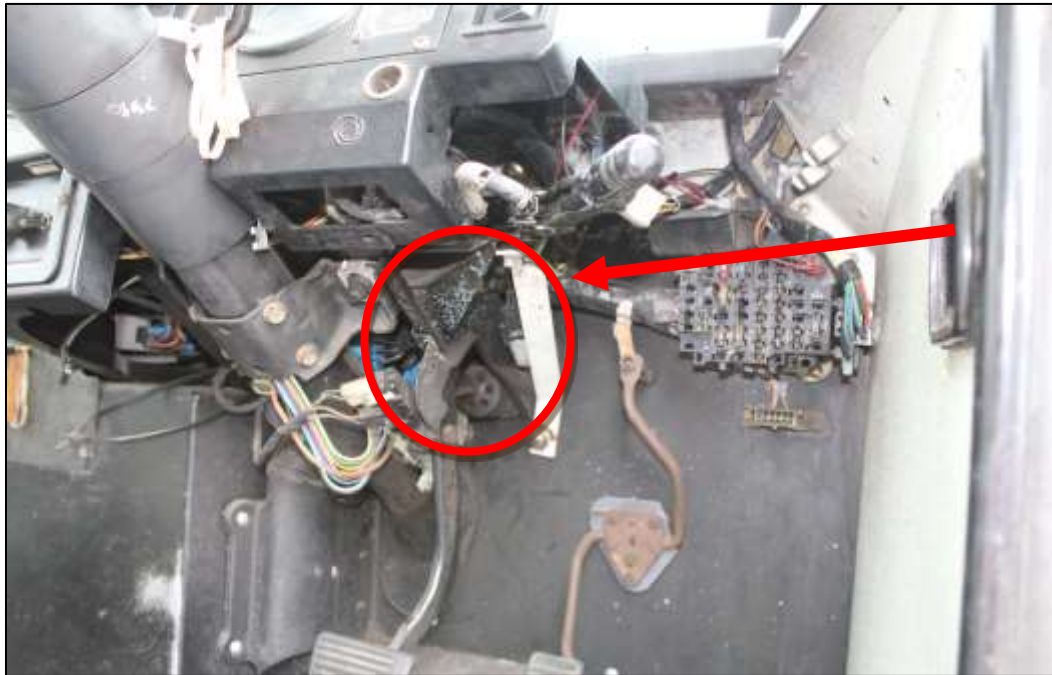
Photograph 9

Looking east and inside, interior of right side of dashboard (oval is spatter pattern; arrow is fire damaged module and wire).

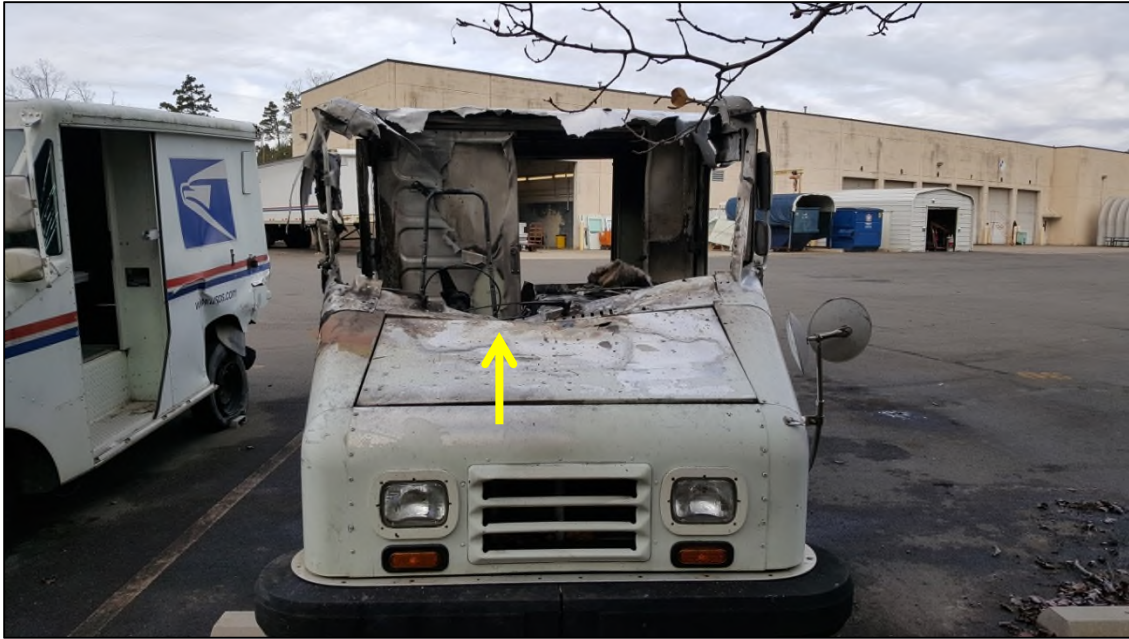
Photograph 3

Observe the severe fire damage to the driver's side dashboard area.

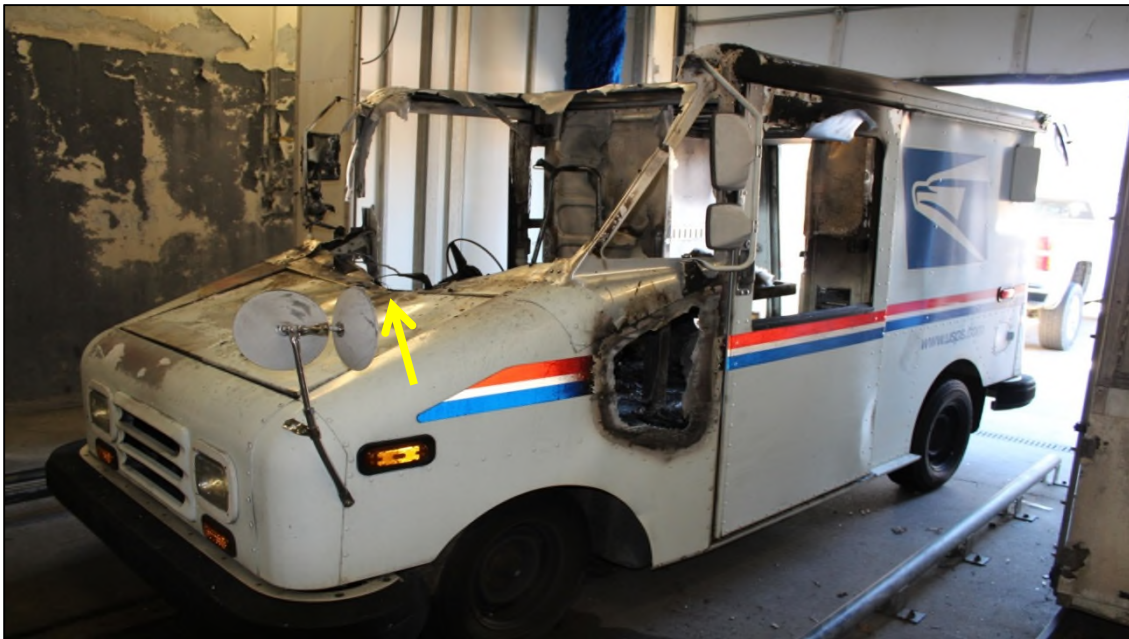
Photograph 4

Observe the less severe fire damage to the left side of the vehicle and the most severe to the driver's side dashboard area.

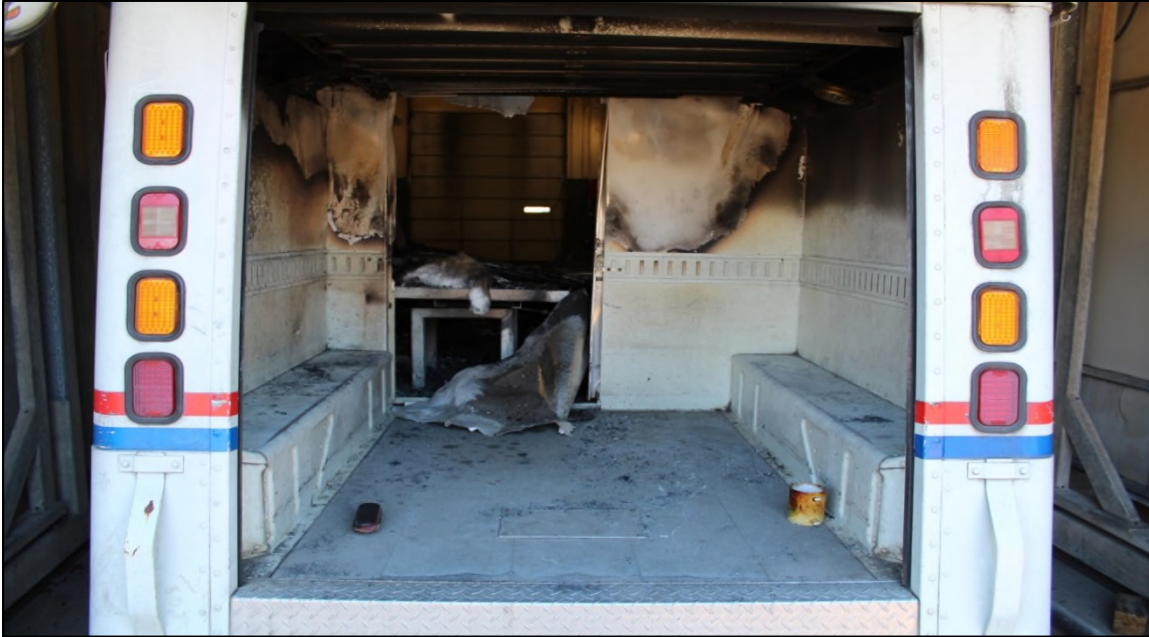
Photograph 5

Observe minor fire damage only to the cargo area and no damage to the rear of the vehicle.
